CALIFORNIA DIVISION OF MINES AND GEOLOGY

Fault Evaluation Report FER-13

December 2, 1976

1. Name of fault: Ventura Fault (also known as the Ventura Foothills fault).
2. Location of fault: Ventura and Saticoy 7.5' quadrangles, Ventura County (this fault passes through the City of Ventura as well).

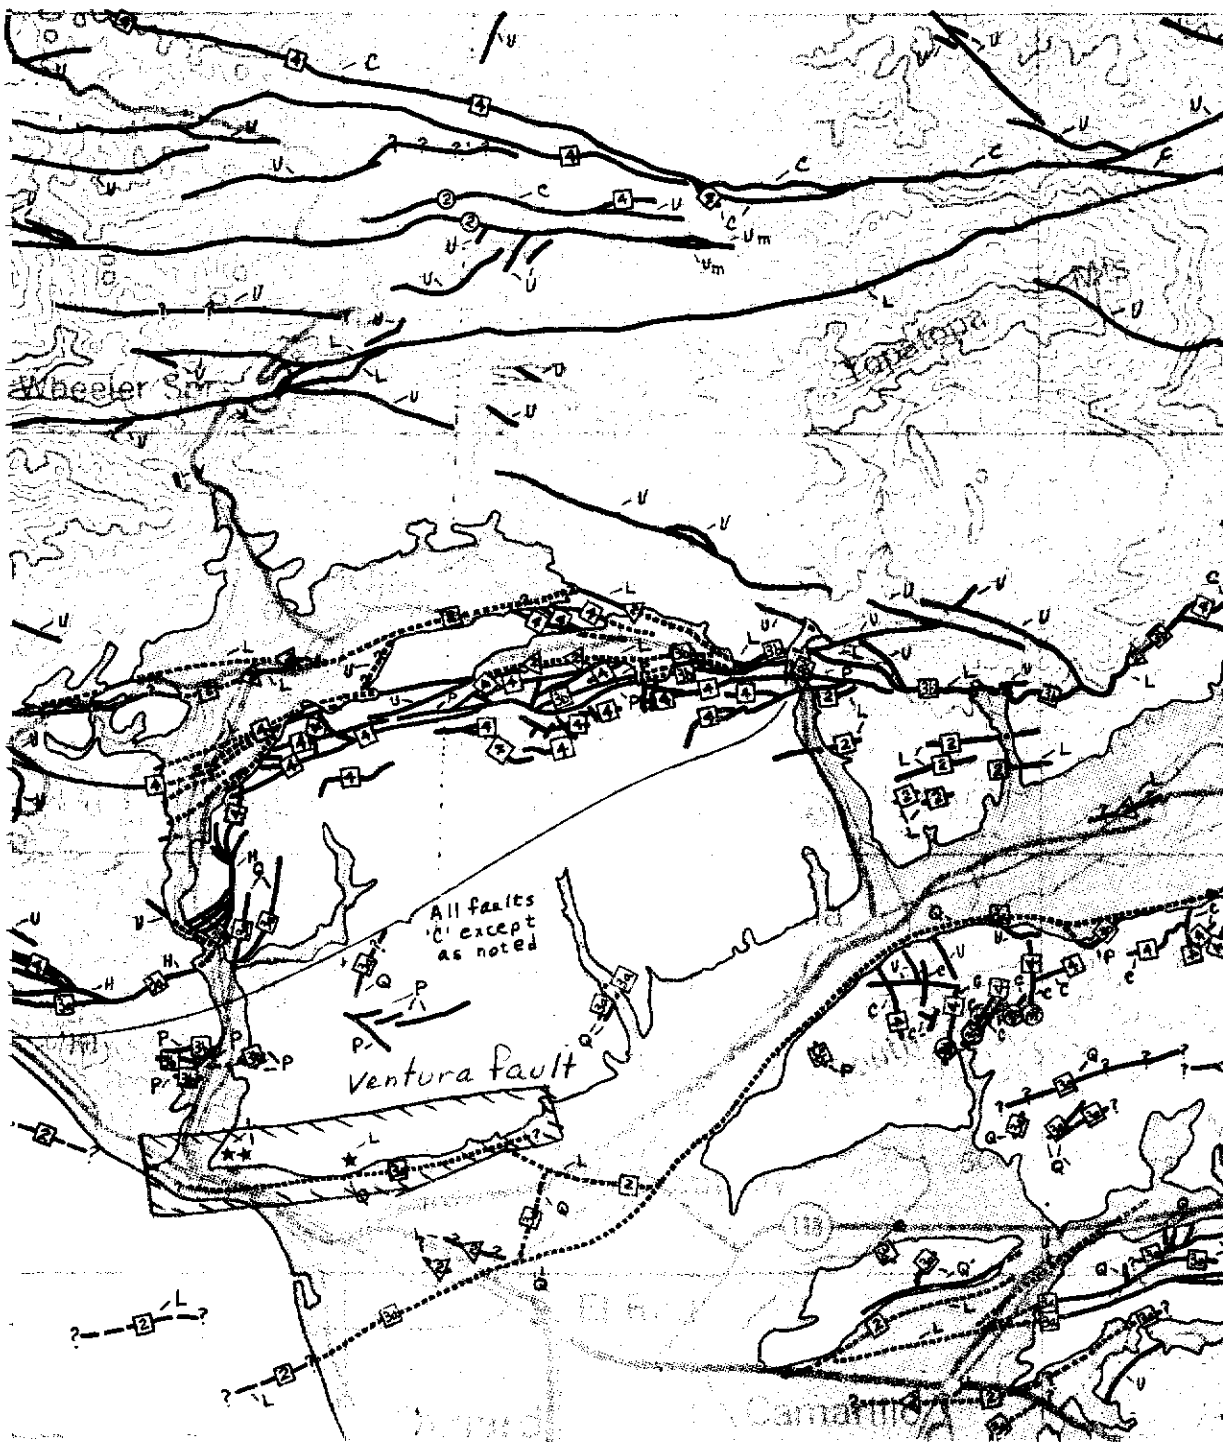
Figure 2: from Ziony, et al., 1974

Jennings (1975), after Ziony, et al. (1974), shows the fault as
a buried fault which cuts units Quaternary in age. Ziony, et al.
also note three late-Quaternary faults immediately north of the
Ventura Foothill fault (see stars in figure 2).

6. Surficial deposits overlying the scarp are deformed by arching and displacement on small faults that penetrate upward to the surface soil [see figure 2, this FER]; progressively-steeper dips downward in the auger holes on and north of the escarpment are also consistent with an interpretation that a fault is present at depth beneath the escarpment, and that movement on the fault has occurred over a considerable span of time;

4. Surficial deposits that overlie the scarp in the Ventura Hospital area are cut by many small faults; the near-surface dip of the north-dipping faults averages about 63° N in a trench across the scarp" [see figure 2, this FER].

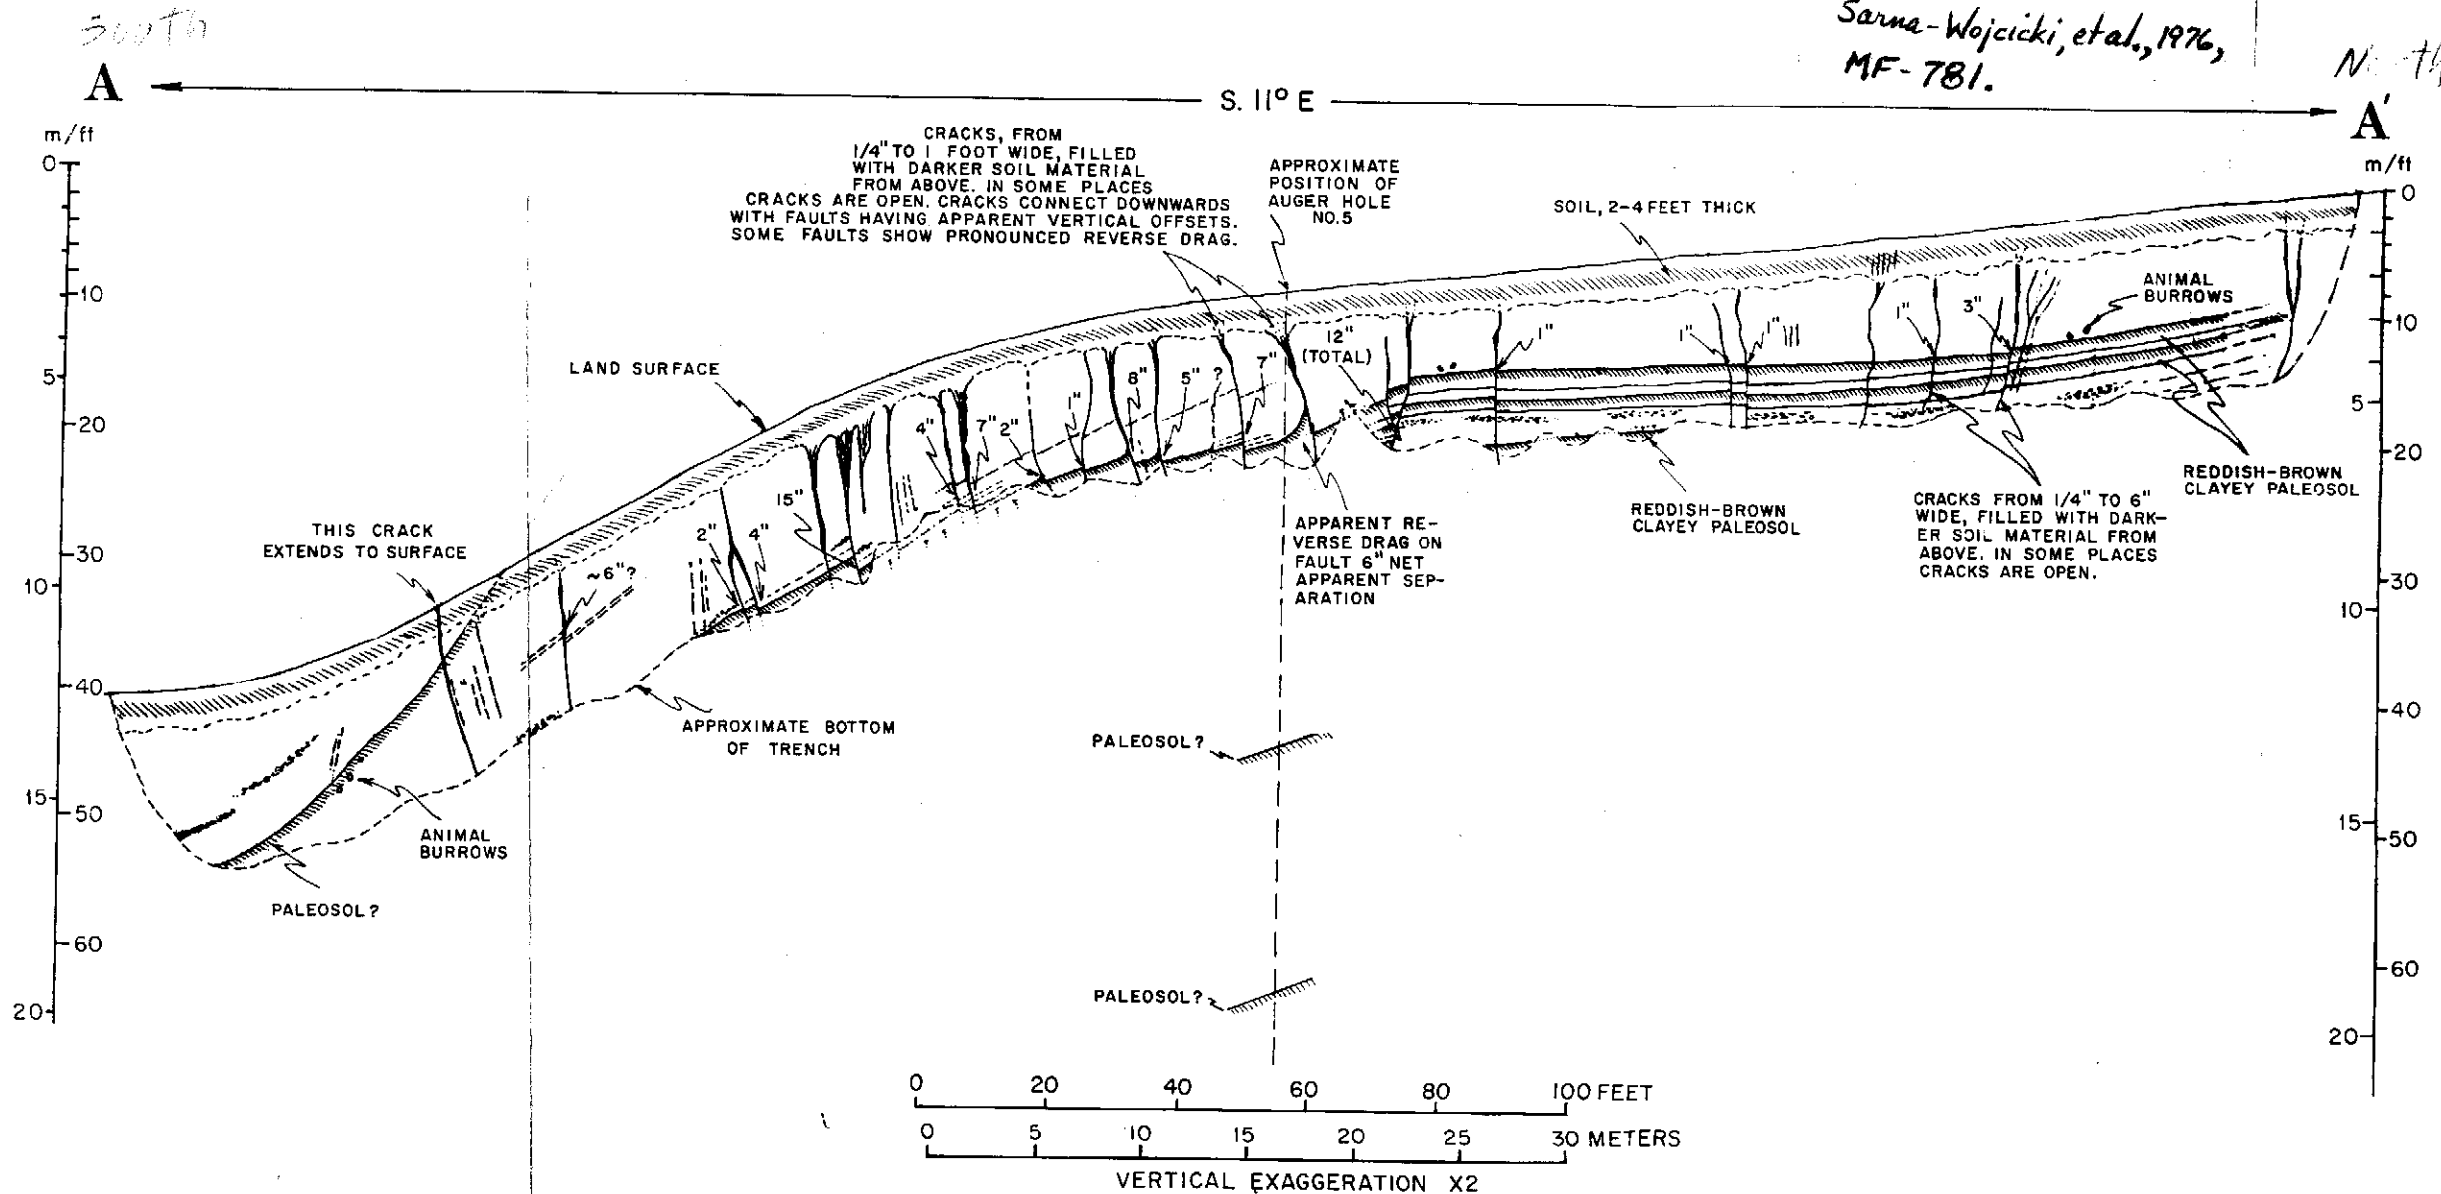
Figure 3. From
Sarna-Wojcicki, et al., 1976,
MF-781.

"Numerous vertical or steeply dipping cracks cut the deposits in the trench [figure 3 of this FER]. Most of these cracks are filled with dark material derived from the soil at the surface, but some are partly open. Most of the cracks, when traced downward, are continuous with high-angle faults, which offset gently- to moderately-dipping alluvium (stream terrace or alluvial fan deposits containing buried paleosols). Apparent vertical dis-

placements on these faults range from about 2 to 40 cm. On the north end of trench A-A', beyond the crest of the escarpment, apparent displacements on the faults are both up and down to the south with fault traces either vertical or steeply dipping, mainly to the south. Near the crest of the escarpment and to the south, apparent displacements are uniformly up on the south, with fault traces dipping steeply to the north [figure 3 of this FER]. The faults strike from N75E to N80W, but nearly east-west strikes are predominant."

"Horizontal slip on the Ventura fault is indicated by the presence of local small folds, having near-vertical axes, in bedrock just north of the fault in the Ventura City area; perhaps by back-tilting on small faults exposed in the south part of trench A-A' [figure 3 in this FER]; and by the focal plane solution for an earthquake attributable to the Ventura fault, which indicates reverse- left-oblique displacement on a surface dipping about 70° NNW."

"Formation of cracks and faults in the surficial deposits (trench A-A' [figure 3 in this FER]) postdates the age of the soil exposed in the uppermost part of the trench, since the cracks are filled with soil material derived from the above. The cracks fade into the soil zone within 60 to 90 cm of the surface, and are indistinguishable from surrounding soil material. In at least one instance, however, an open crack extends all the way through the soil profile to the surface. In other instances, some cracks are unfilled or only partially filled, suggesting that they may have formed at different times."

"The age of the surface soil exposed in trench A-A' [figure 3 in this FER] north of the base of the lineament at the Ventura County Hospital grounds is probably no older than Wisconsinan (10,000 to 70,000 years before present). From evidence in these trenches, some of the movement on the fault is at least as young as Wisconsinan (70,000 years) and may be younger."

Figure 5. Log of trench A-A' on Ventura County Hospital grounds. Steeply inclined, irregular lines represent cracks, most of which connect downward with faults having measurable apparent vertical displacements. Amounts (inches) of apparent offsets are shown adjacent to the fault traces. Widths of cracks are exaggerated. Dips corrected for vertical exaggeration (2 times). See center of map sheet 2 for location.
